## Inspection Report

**To:** Jill Buckley (NRG Cheswick Generating Station)  
**From:** Jesse Varsho, P.E.  
**Re:** Cheswick Ash Disposal Site – Annual CCR Unit Inspection Report No. 1  
**Inspection Date:** October 14, 2015  
**Report Date:** January 12, 2016

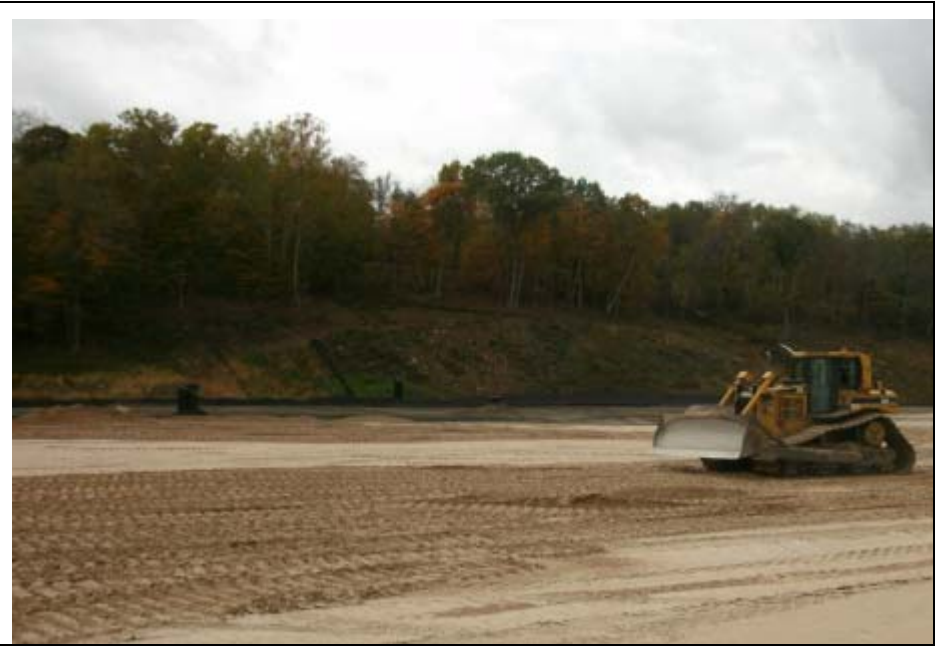
**Photograph No. 1**

**Description:**  
Ongoing CCR placement, grading and compaction.

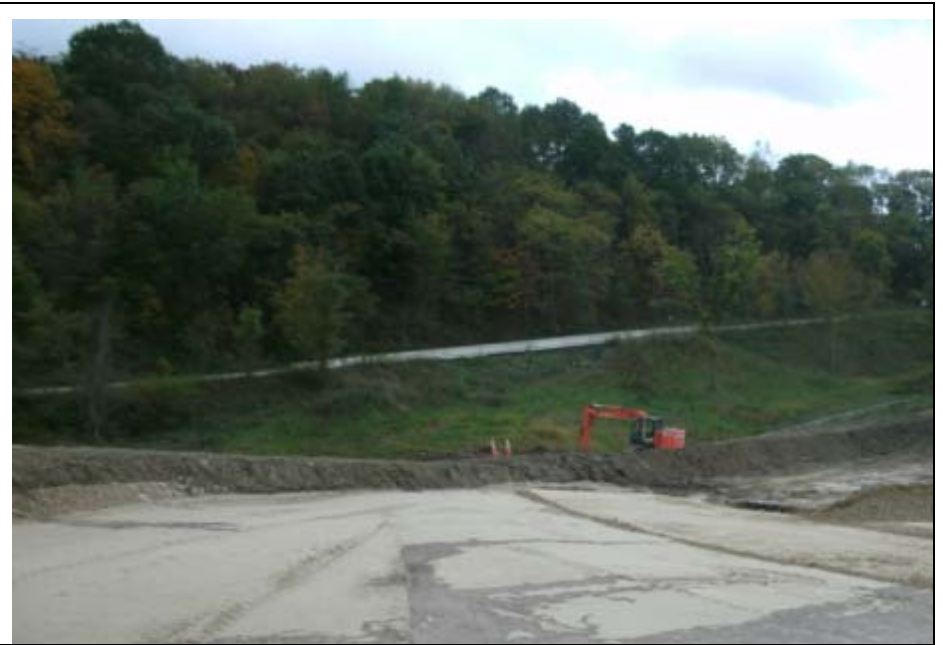
**Photograph No. 2**

**Description:**  
Ongoing maintenance of existing perimeter stormwater ditch.

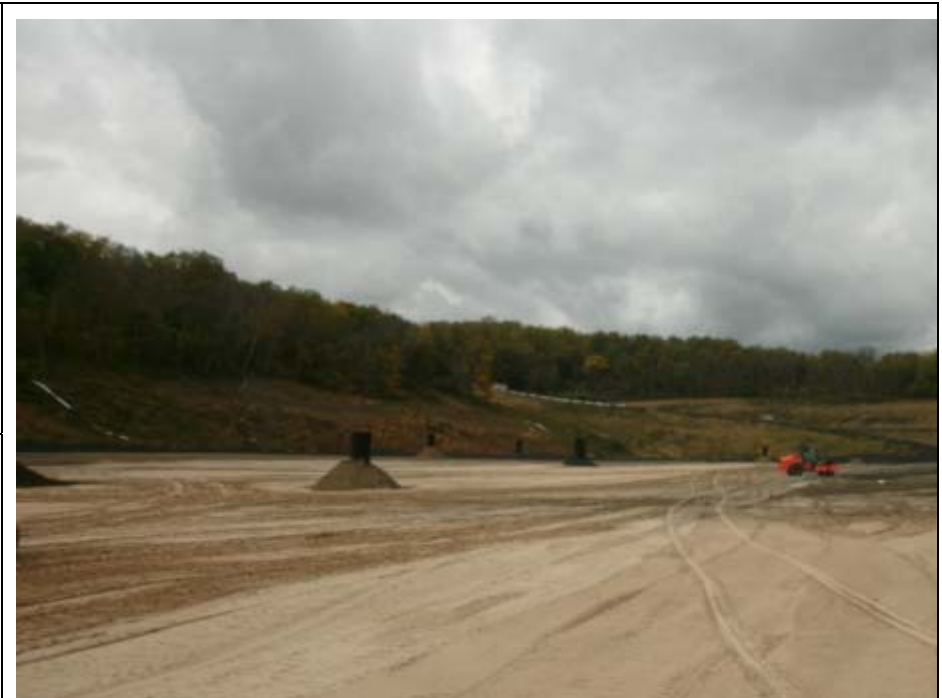
| <p><b>Photograph No. 3</b></p> <p><b>Date:</b><br/>October 14, 2015</p> <p><b>Location of Photograph:</b><br/>Southeast corner of the active fill operations area</p> | |

| <p><b>Description of Photograph:</b><br/>Leachate manholes (surrounded by bottom ash) connected to base piping system. Stormwater manholes (surrounded by gypsum) to manage stormwater once final cover is placed.</p> | |

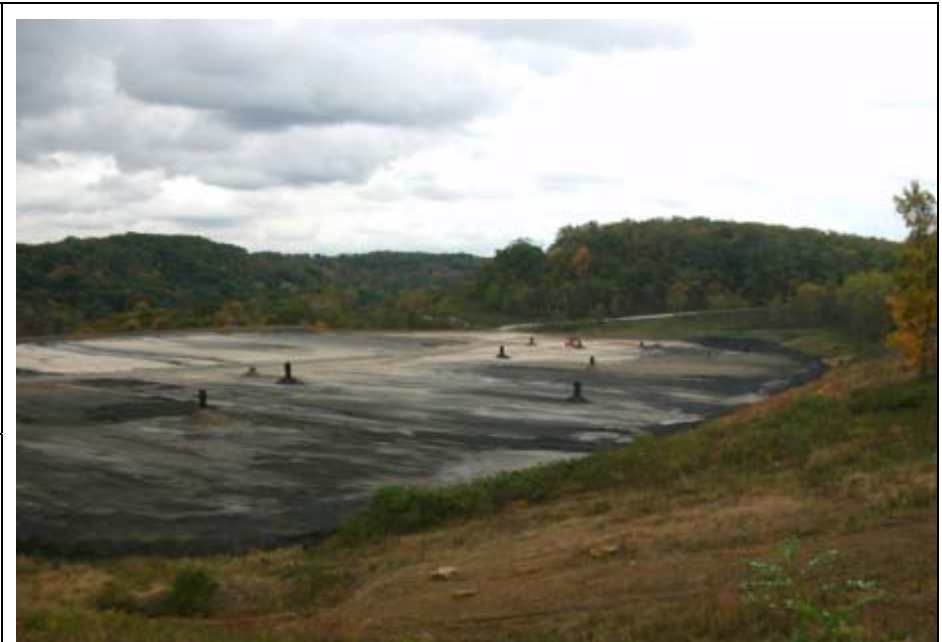
| <p><b>Photograph No. 5</b></p> <p><b>Date:</b><br/>October 14, 2015</p> <p><b>Location of Photograph:</b><br/>Along access road</p> | |

| <p><b>Description of Photograph:</b><br/>Looking southeast along active fill area.</p> | |

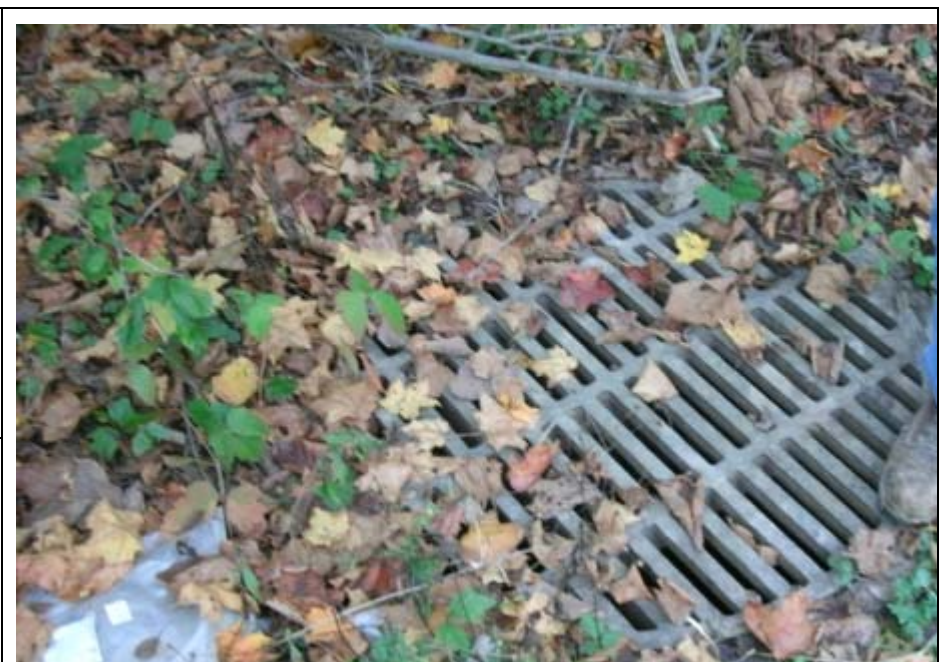
| <p><b>Photograph No. 6</b></p> <p><b>Date:</b><br/>October 14, 2015</p> <p><b>Location of Photograph:</b><br/>Near eastern limits of solid waste permit boundary</p> | |

| <p><b>Description of Photograph:</b><br/>Leachate conveyance point to the Monarch Mine Dewatering Plant; both visual and audible evidence of leachate flow were noted during the inspection.</p> | |

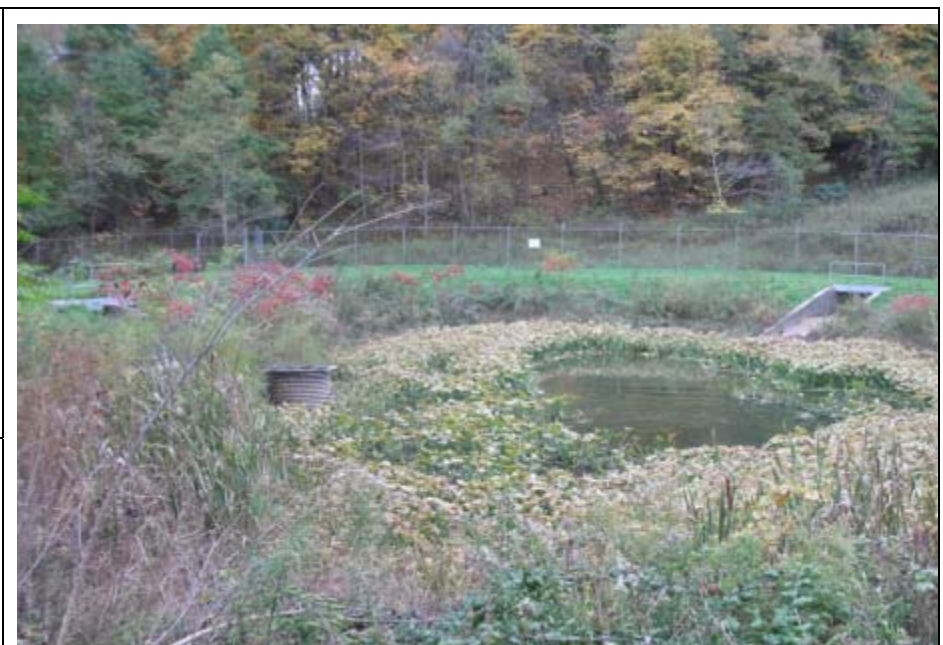
| <p><b>Photograph No. 8</b></p> <p><b>Date:</b><br/>October 14, 2015</p> <p><b>Location of Photograph:</b><br/>Adjacent to sedimentation pond</p> | |

| <p><b>Description of Photograph:</b><br/>Looking south across existing sedimentation pond.</p> | |

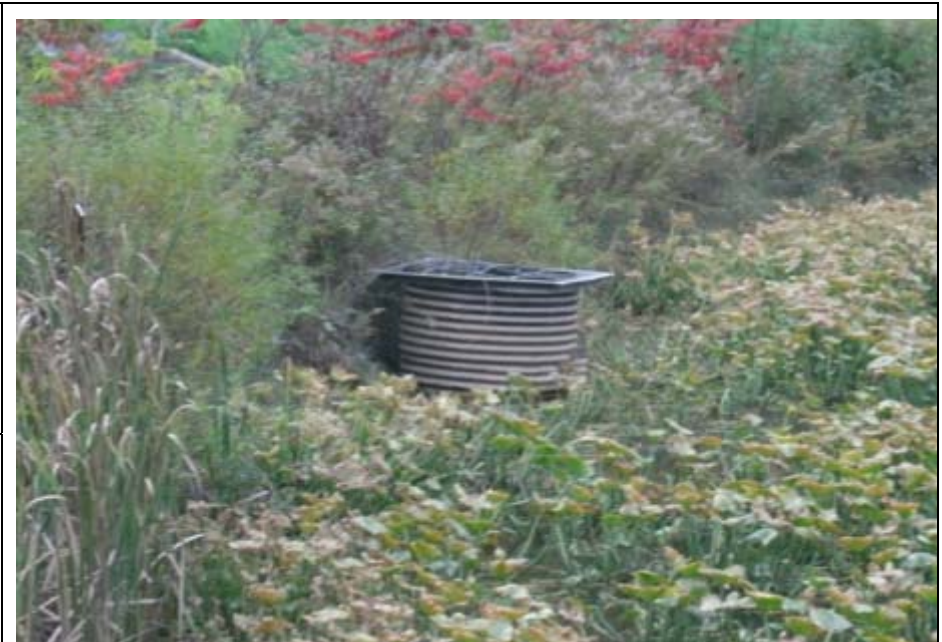
| <p><b>Description of Photograph:</b><br/>Principal discharge structure; both visual and audible evidence of stormwater flow was noted during the inspection.</p> | |
