Inspection Report

Re: New Castle Plant Ash Landfill – Annual CCR Unit Inspection Report No. 1

Inspection Date: October 13, 2015

Report Date: January 14, 2016

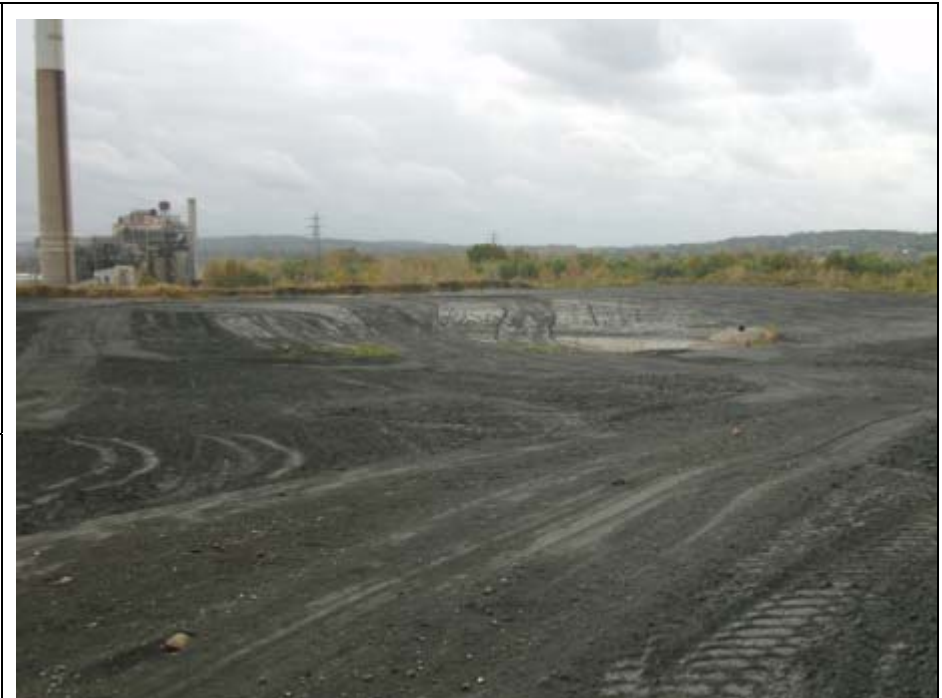
<p>Photograph No. 3</p> <p>Date: October 13, 2015</p> <p>Location of Photograph: Plateau of active area</p>

<p>Description of Photograph: Looking southwest at active portion of the landfill (Stage 4).</p>

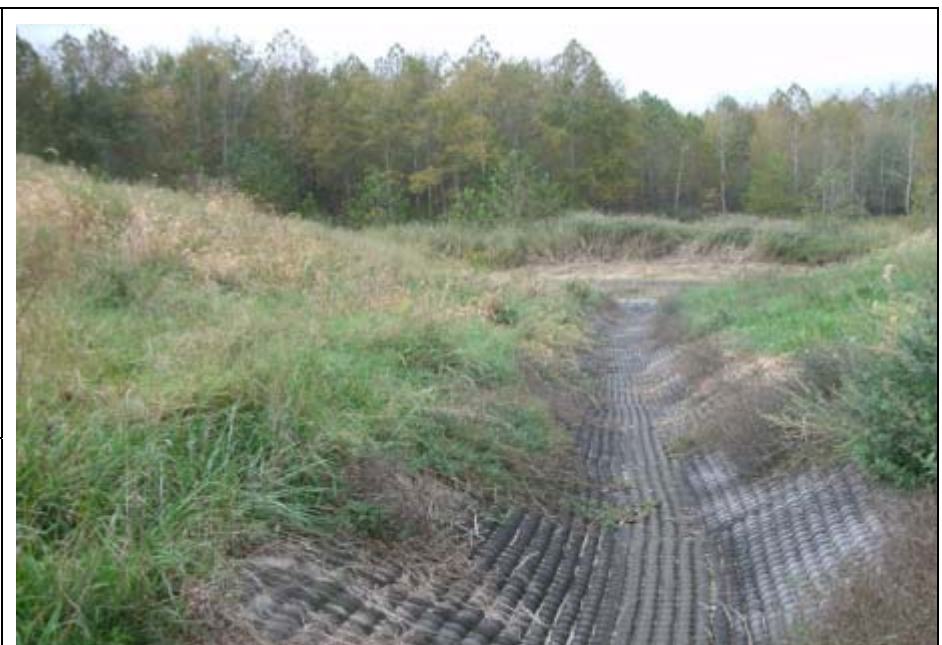
<p>Photograph No. 6</p> <p>Date: October 13, 2015</p> <p>Location of Photograph: Western side slopes</p>

<p>Description of Photograph: Stormwater ditch (Downchute 7).</p>

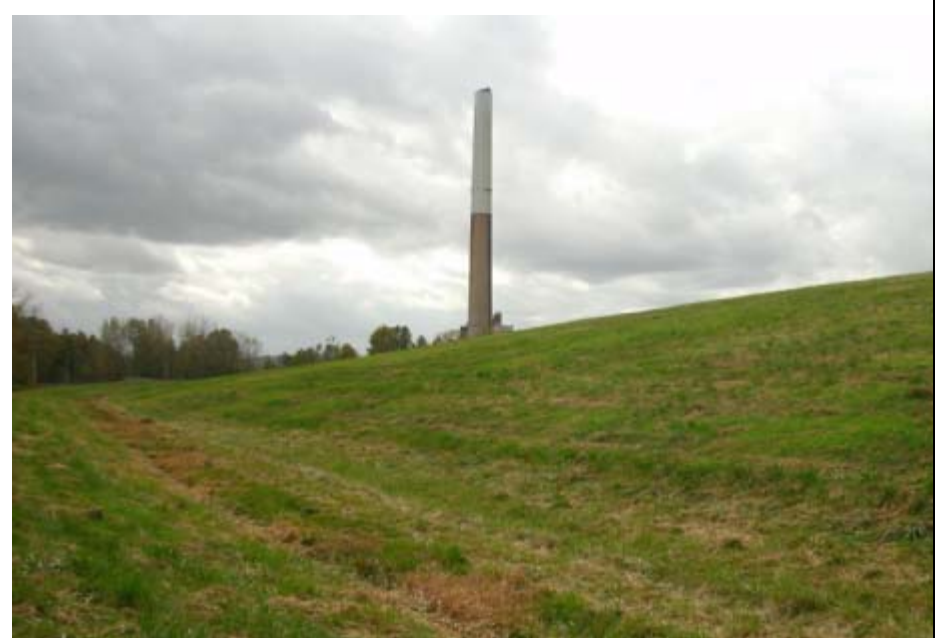
Photograph No. 13

Looking south along perimeter ditch and toe of final capped and vegetated slopes; no evidence of sloughing at toe of slope.
