**ANNUAL CCR UNIT INSPECTION REPORT
2022**

**NEW CASTLE STATION ASH LANDFILL
WEST PITTSBURG, LAWRENCE COUNTY, PENNSYLVANIA**

**INSPECTION DATE: 11/7/2022
REPORT DATE: 1/13/2023**

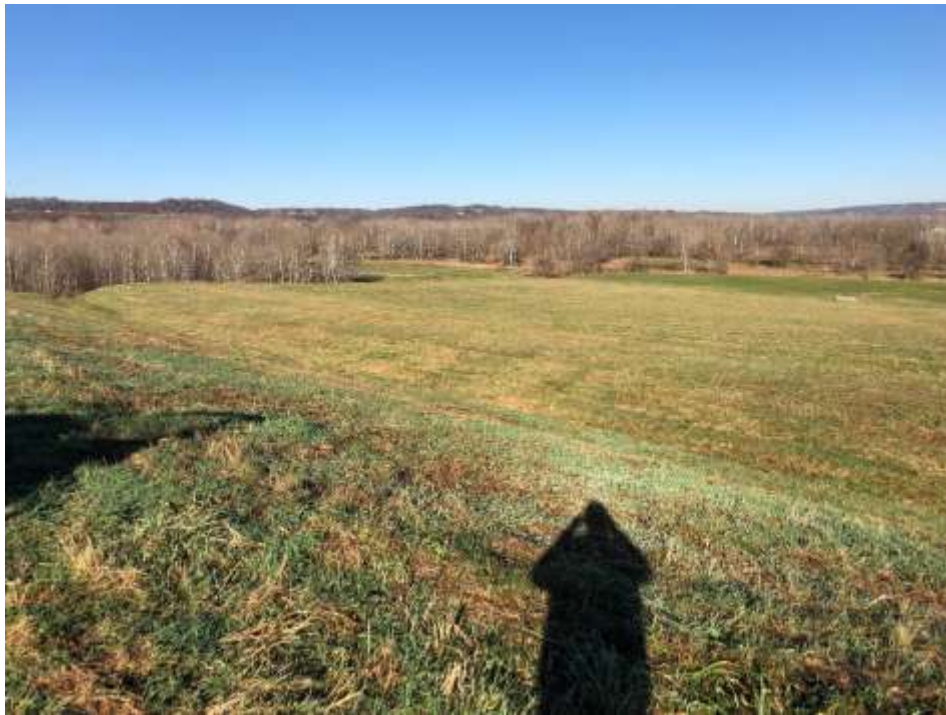
Photograph 1: Stage 5 final cover is well vegetated and mowed annually. No evidence of animal burrows, erosion, or stability issues.

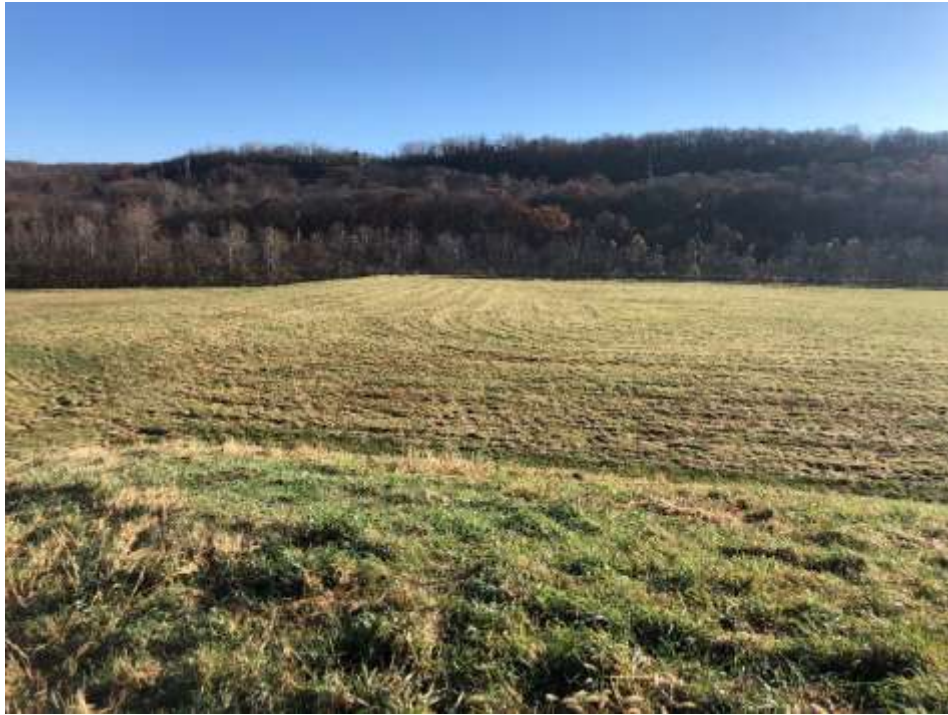
Photograph 3: Stage 6 final cover is well vegetated and mowed annually. No evidence of animal burrows, erosion, or stability issues.

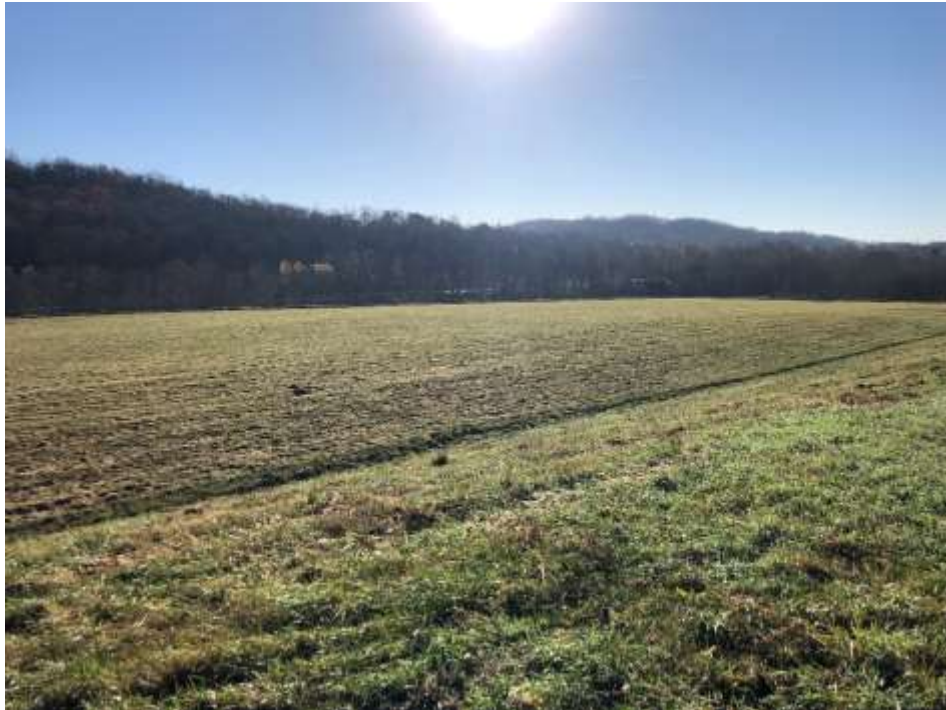
Photograph 4: Stage 6 final cover is well vegetated and mowed annually. No evidence of animal burrows, erosion, or stability issues.

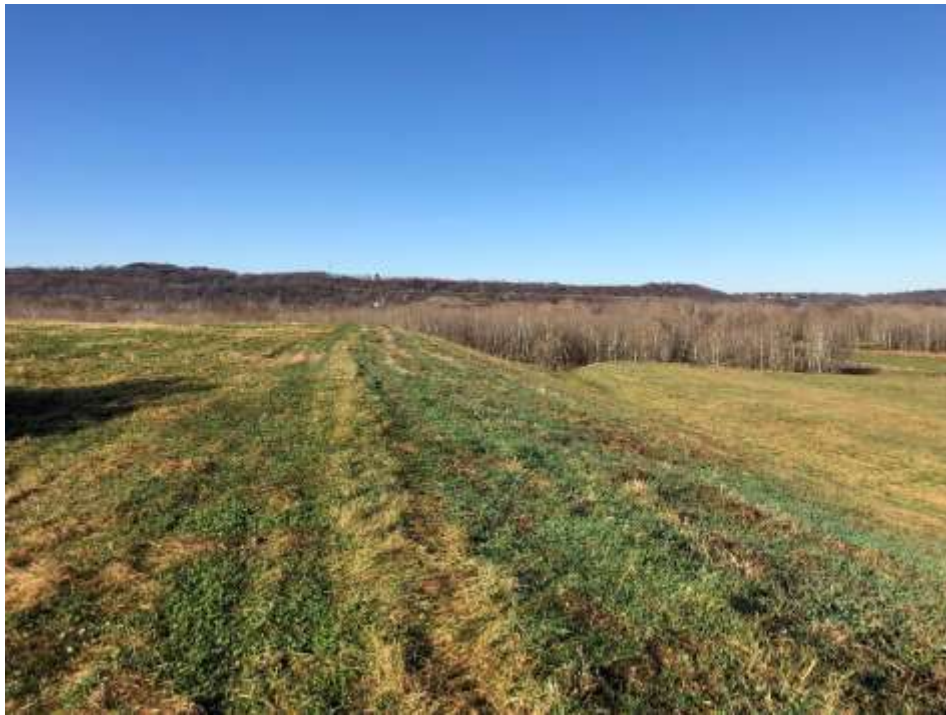
Photograph 5: Stage 4 north slope is well vegetated and mowed annually. No evidence of animal burrows, erosion, or stability issues.

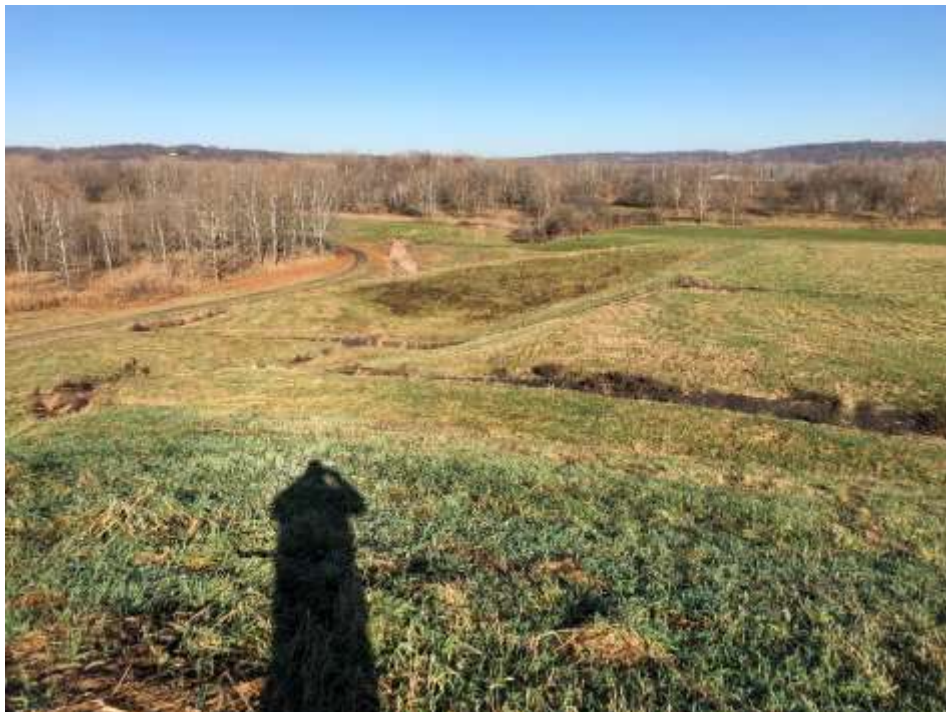
Photograph 6: Downchutes from west side of Stage 4 and Stage 5. No evidence of animal burrows, erosion, or stability issues on the vegetated slopes.

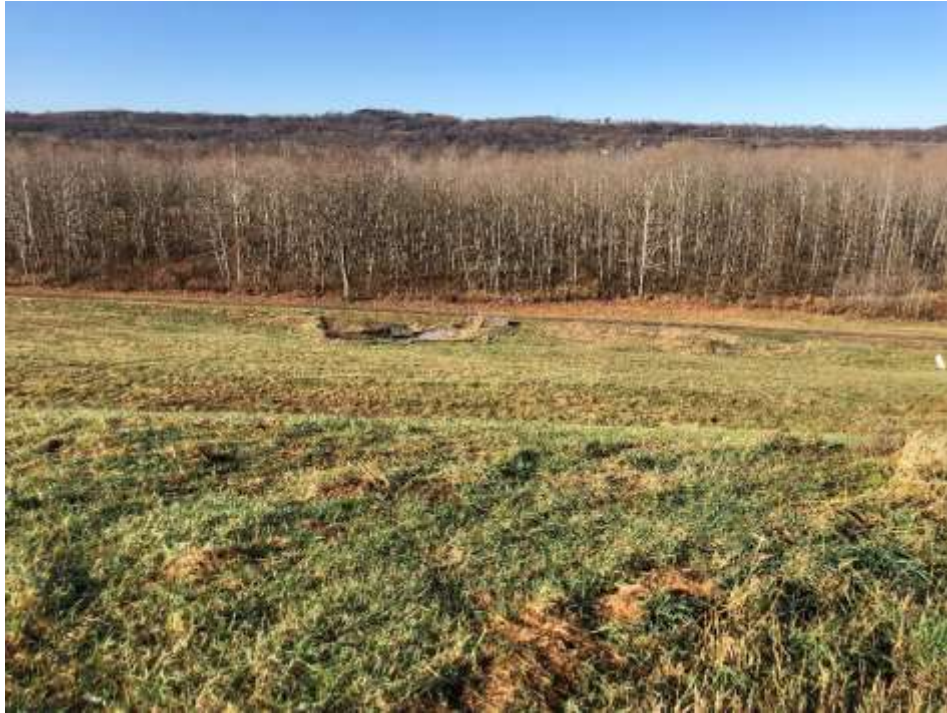
Photograph 7: Stage 4 west slope is well vegetated and mowed annually. No evidence of animal burrows, erosion, or stability issues on the vegetated slopes.

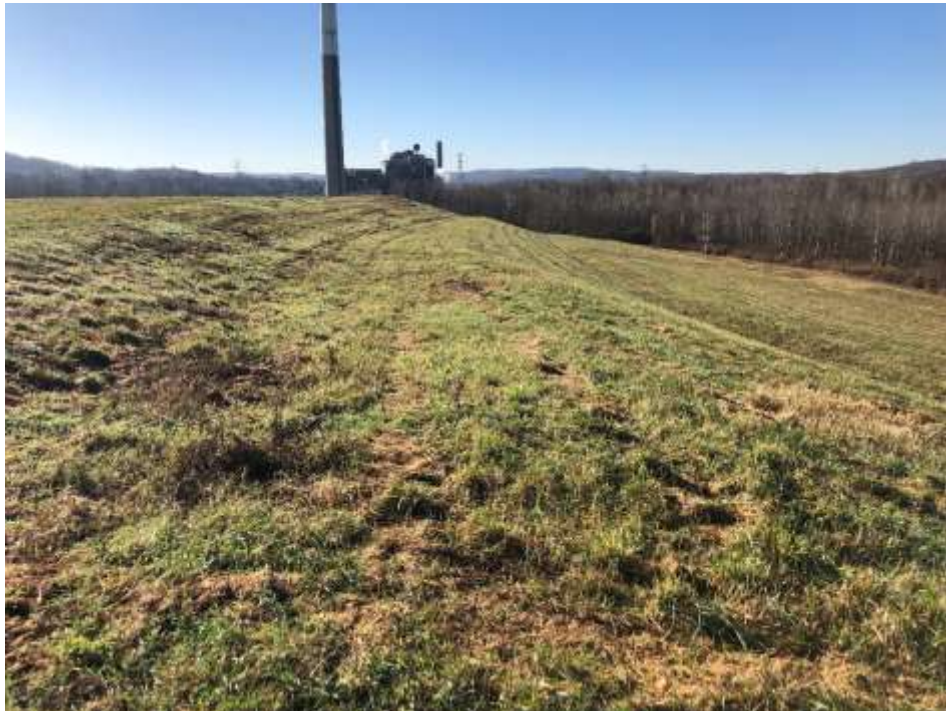
Photograph 8: Stage 4 west slope is well vegetated and mowed annually. No evidence of animal burrows, erosion, or stability issues.

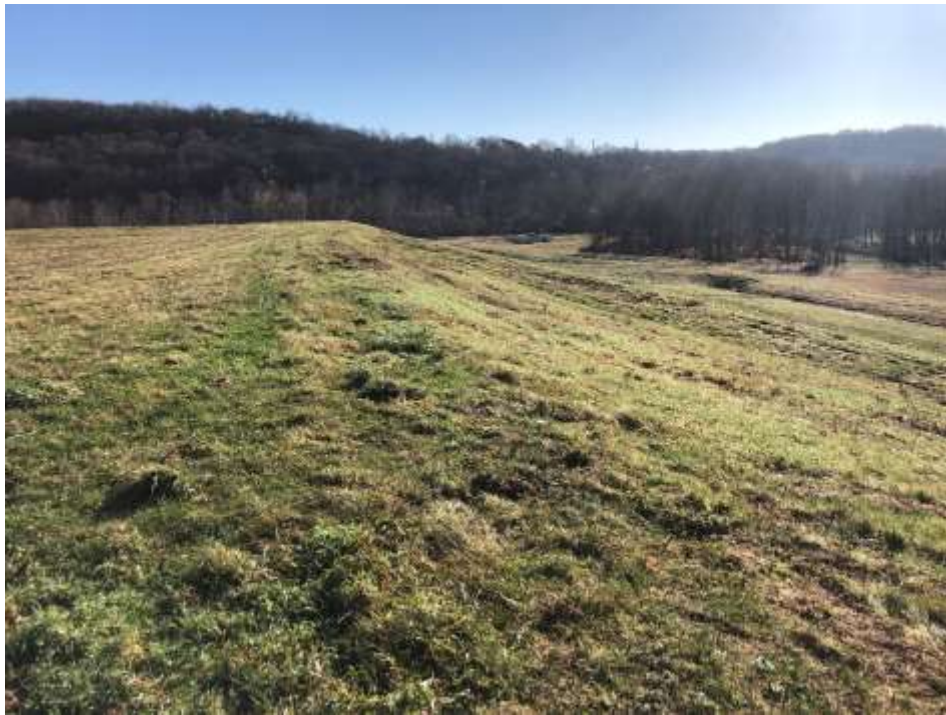
Photograph 9: Stage 4 south slope is well vegetated and mowed annually. No evidence of animal burrows, erosion, or stability issues.

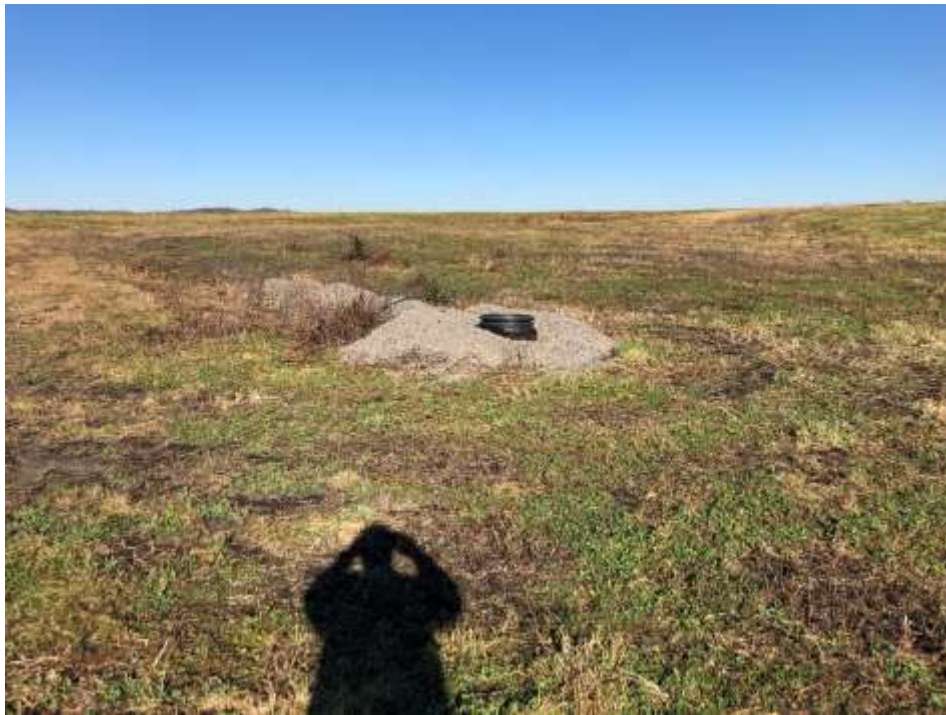
Photograph 15: Contact water collection riser in active area.

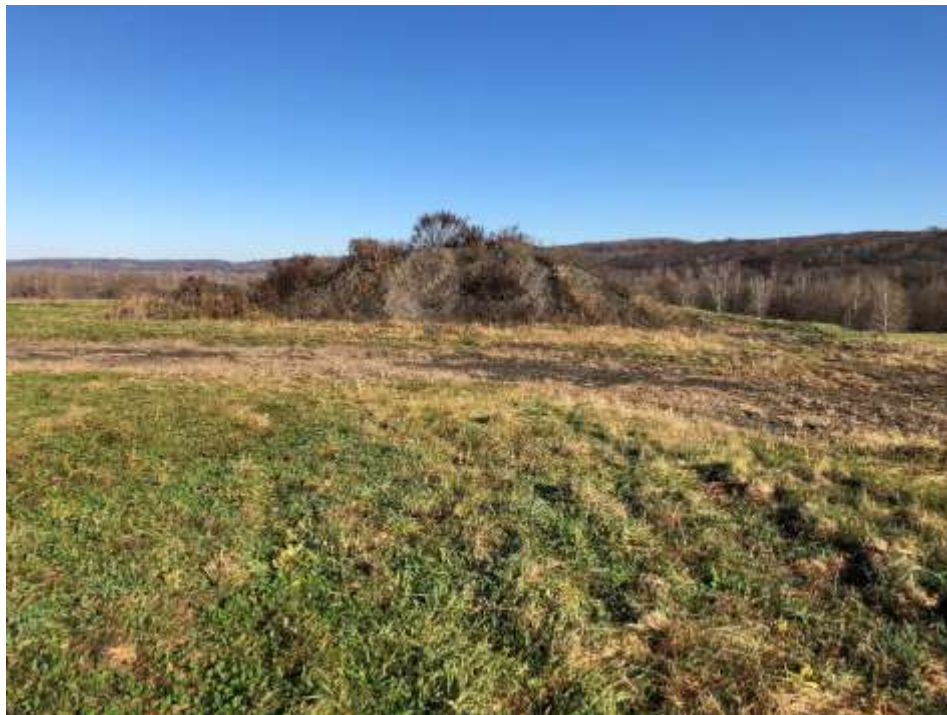
Photograph 17: Intermediate cover in active area is well vegetated and mowed annually. Bottom ash storage pile.

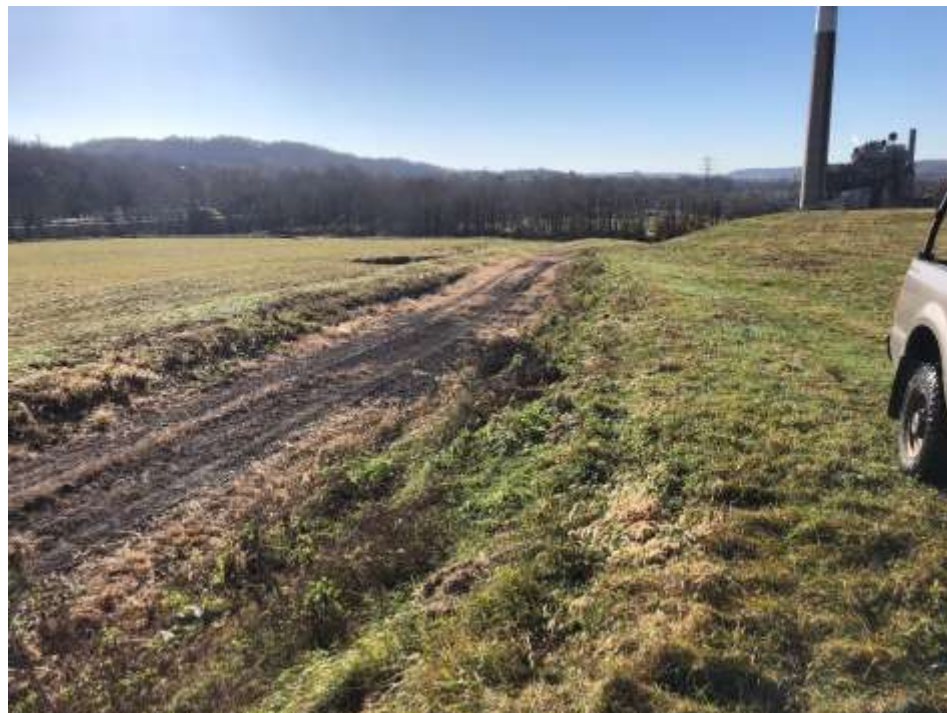
Photograph 18: Access road is well maintained.

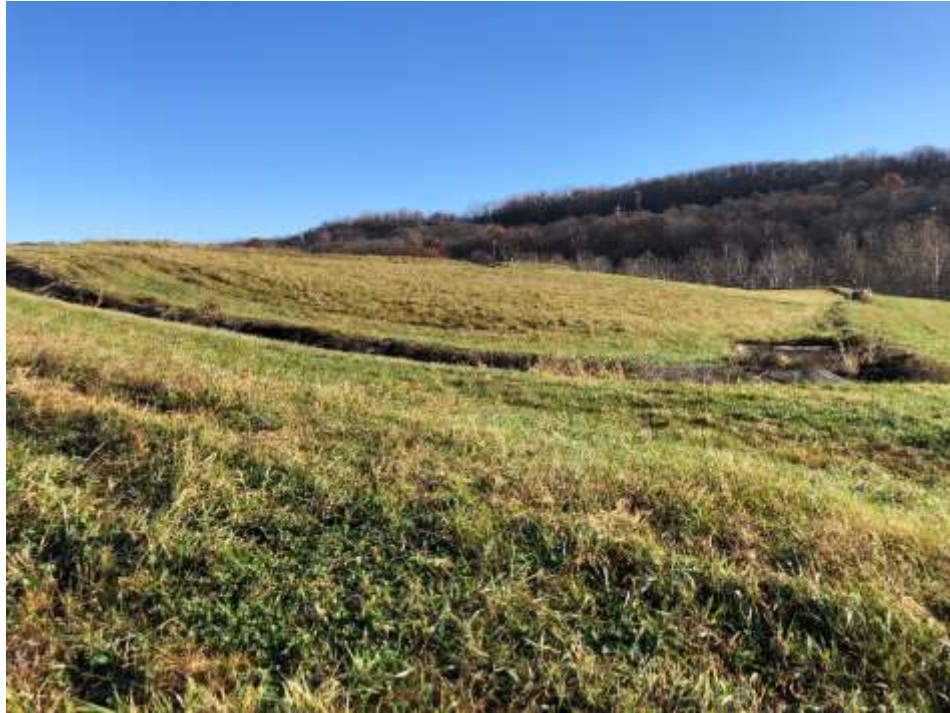
Photograph 19: South non-contact stormwater bench is clear of obstructions. South final cover upper slope is well vegetated and mowed annually. No evidence of animal burrows, erosion, or stability issues.

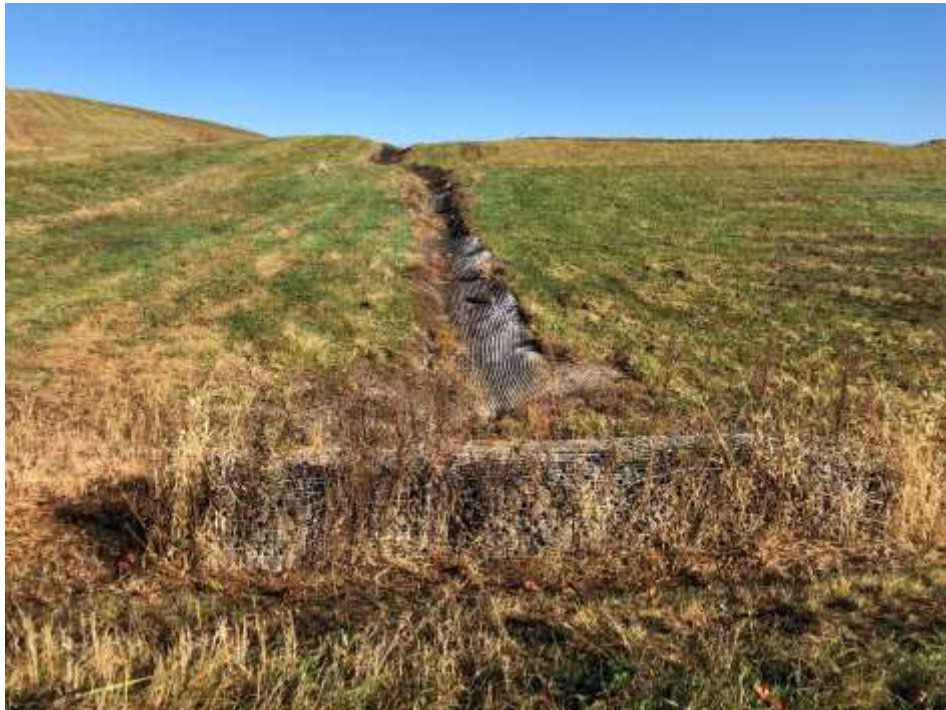
Photograph 22: Non-contact stormwater downchute is clear of obstructions. Gabion energy dissipator is installed at the junction with the stormwater (non-contact water) perimeter ditch.

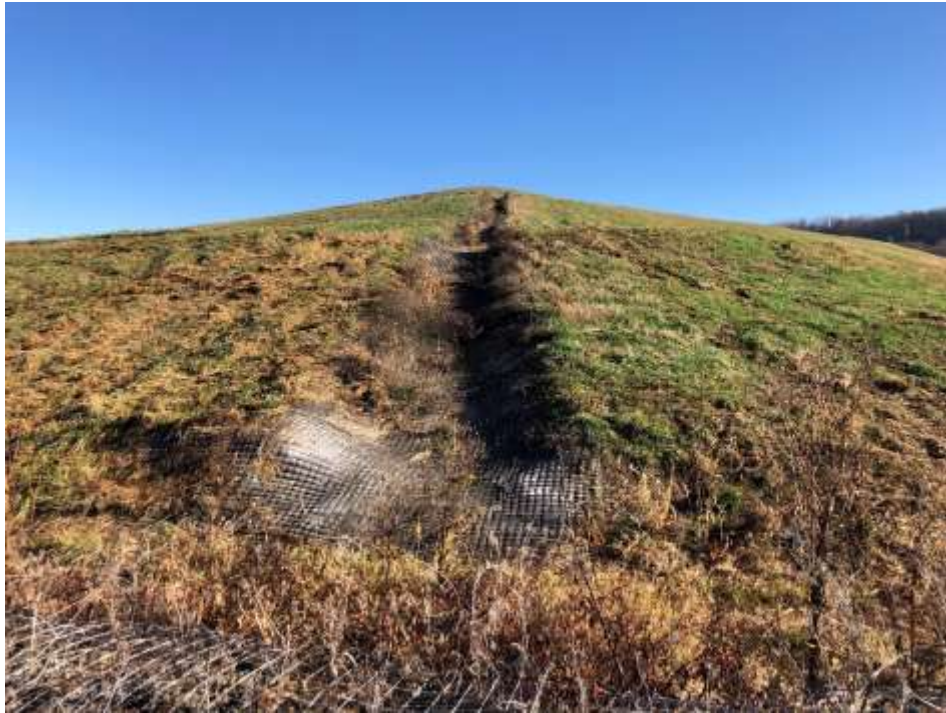
Photograph 27: Non-contact stormwater downchute is clear of obstructions. Gabion energy dissipator is installed at the junction with the stormwater perimeter ditch.

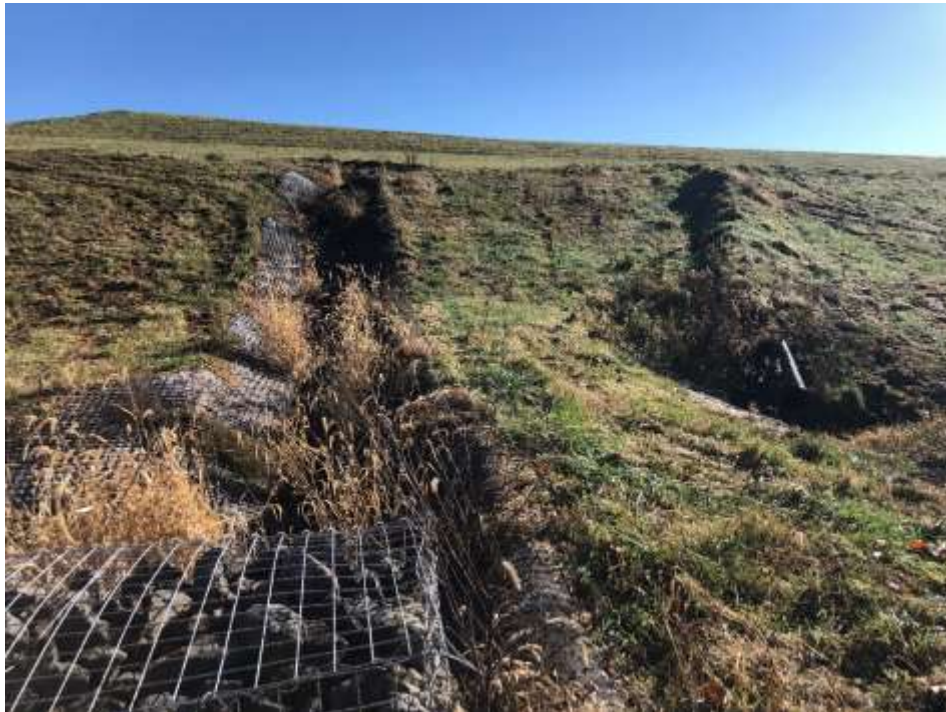
Photograph 28: Non-contact stormwater downchute is clear of obstructions. Gabion energy dissipator is installed at the junction with the stormwater perimeter ditch.

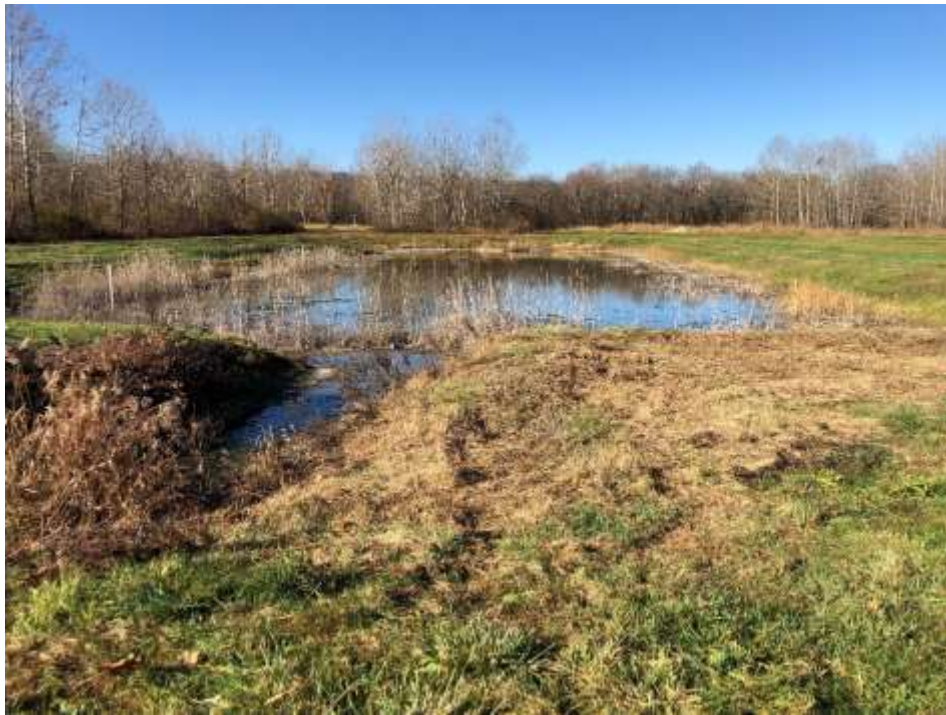
Photograph 33: Leachate (contact water) Pond. No evidence of animal burrows or liner damage.

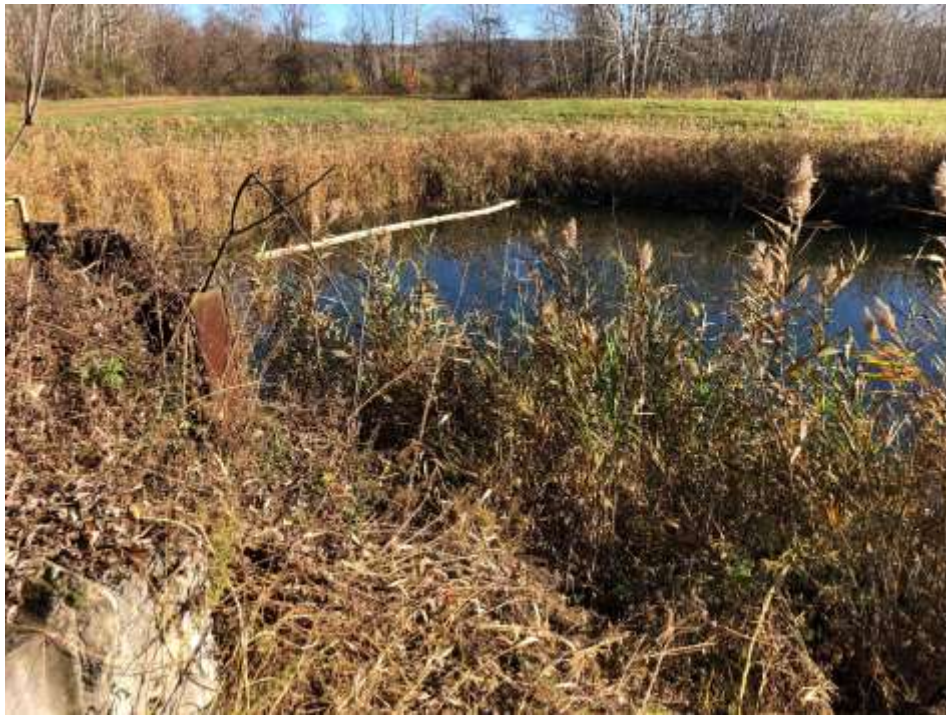
Photograph 35: Non-contact stormwater Sedimentation Pond.

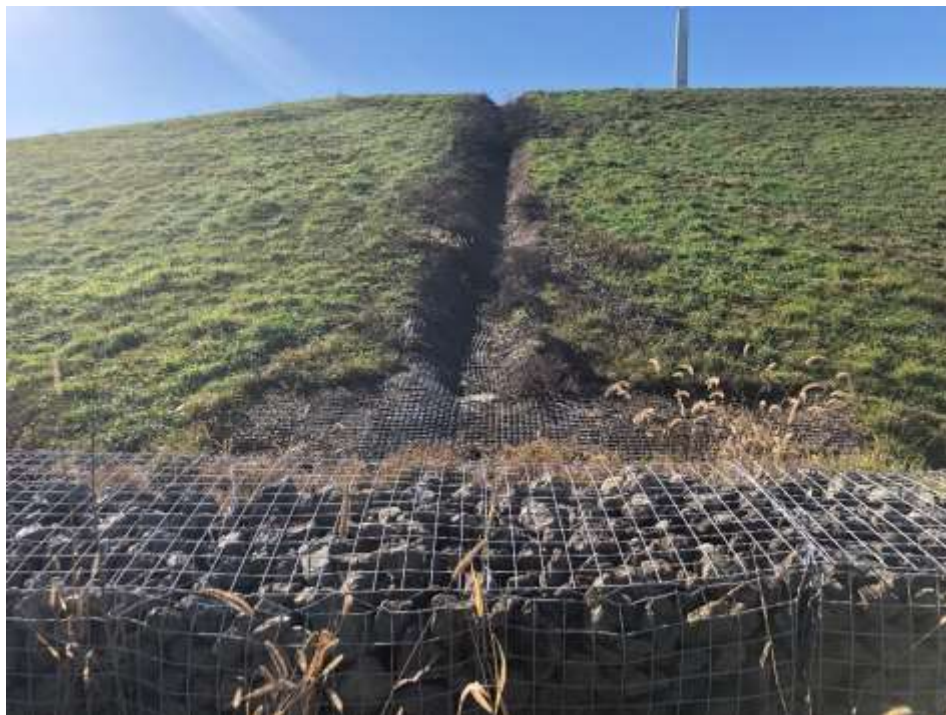
Photograph 37: Non-contact stormwater downchute is clear of obstructions. Gabion energy dissipator is installed at the junction with the stormwater (non-contact water) perimeter ditch.

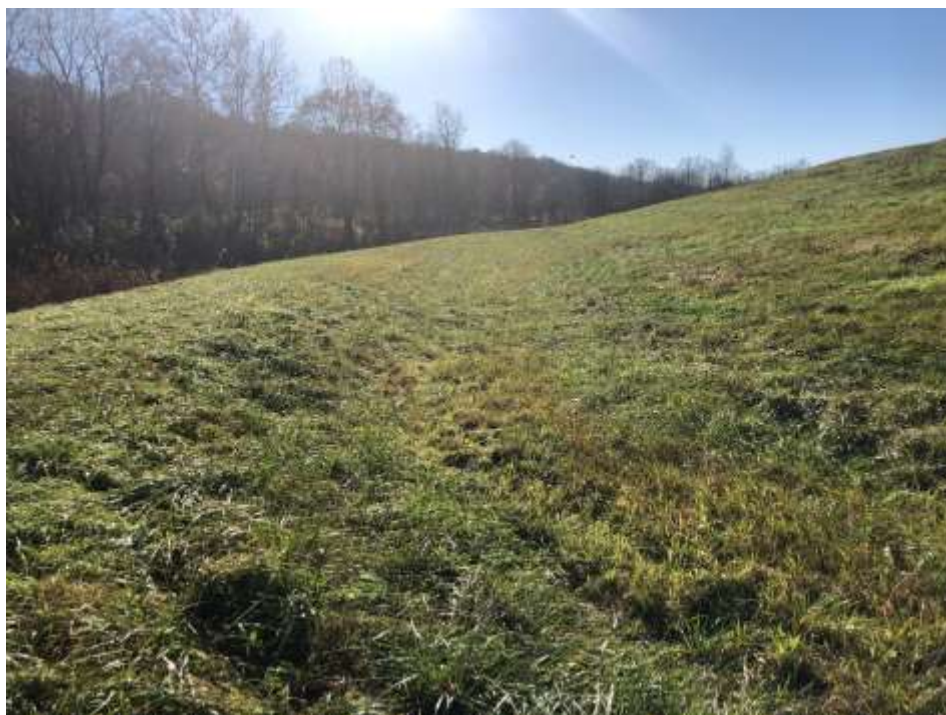
Photograph 38: East non-contact stormwater channel is clear of obstructions. East final cover lower slope is well vegetated and mowed annually. No evidence of animal burrows, erosion, or stability issues.

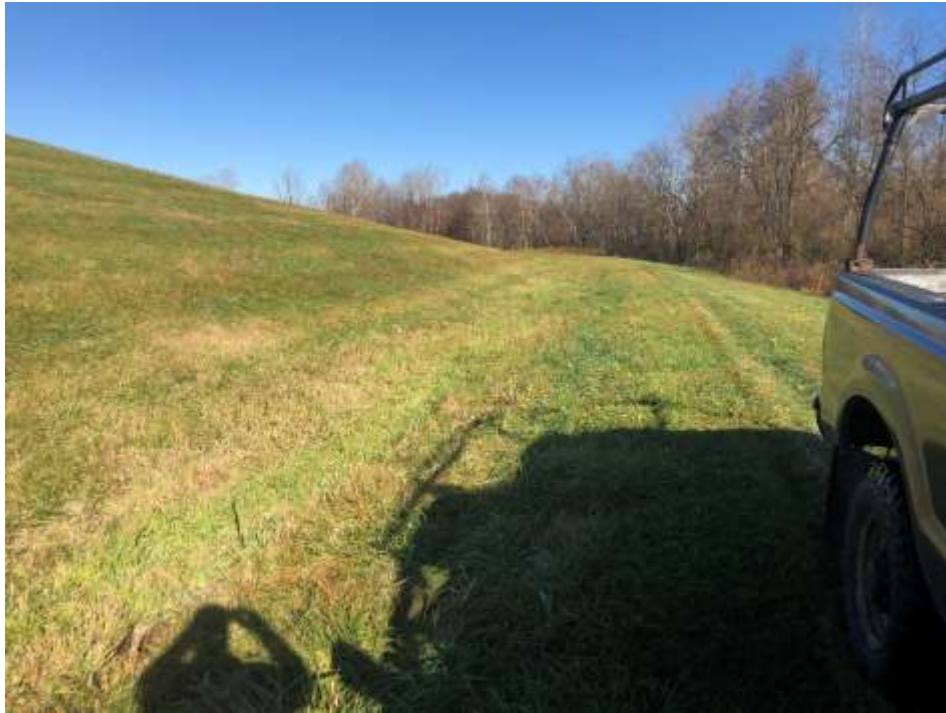
Photograph 41: East non-contact stormwater channel is clear of obstructions. East final cover lower slope is well vegetated and mowed annually. No evidence of animal burrows, erosion, or stability issues.

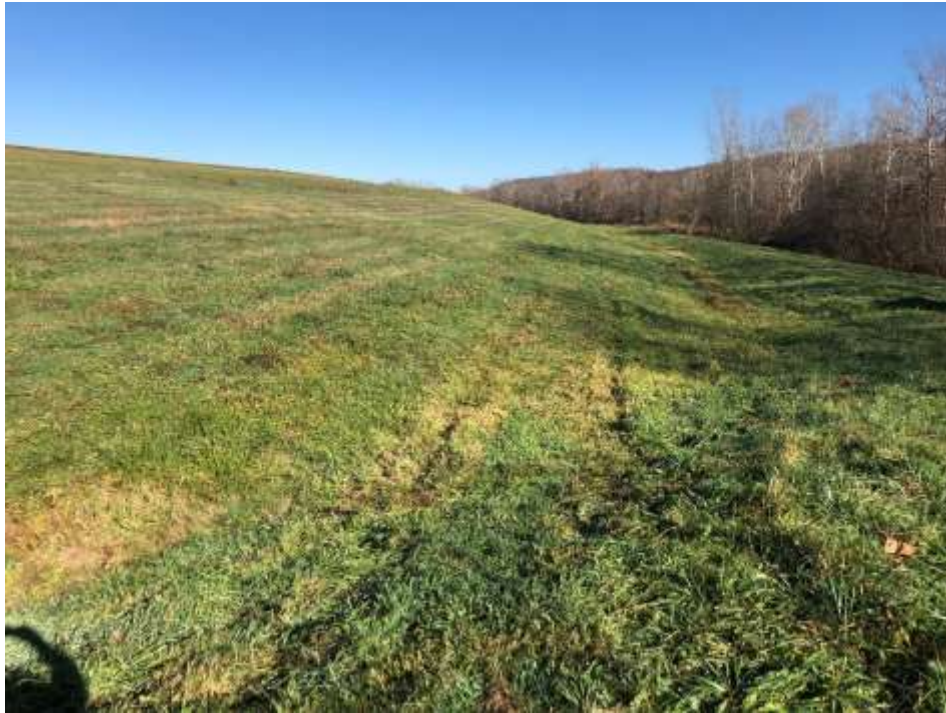
Photograph 43: East non-contact stormwater channel is clear of obstructions. East final cover lower slope is well vegetated and mowed annually. No evidence of animal burrows, erosion, or stability issues.

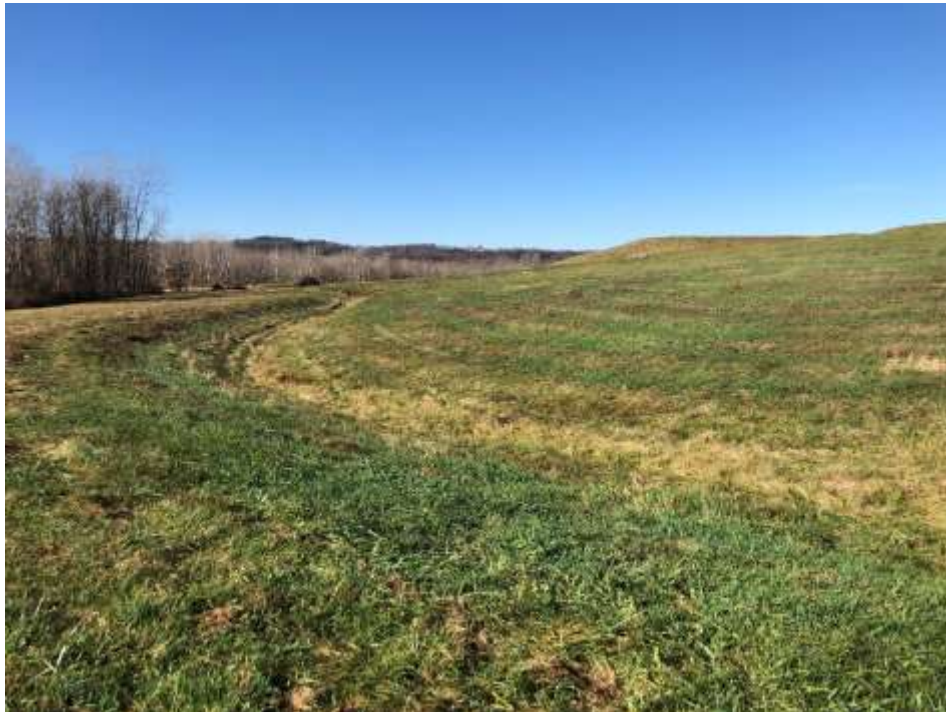
Photograph 44: South non-contact stormwater channel is clear of obstructions. South final cover lower slope is well vegetated and mowed annually. No evidence of animal burrows, erosion, or stability issues.

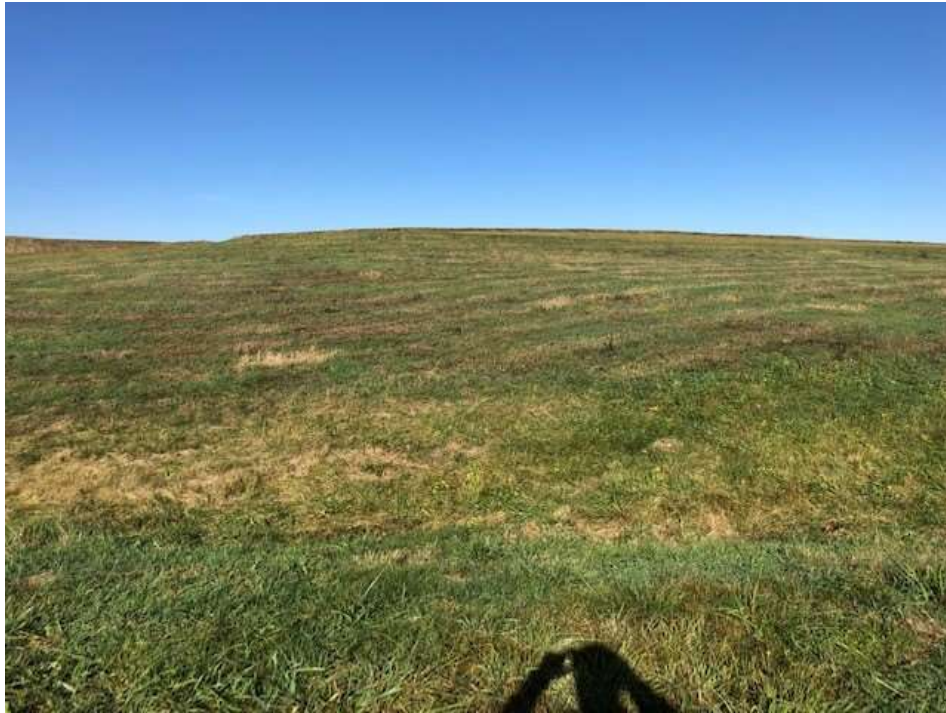
Photograph 45: Southeast corner final cover lower slope is well vegetated and mowed annually. No evidence of animal burrows, erosion, or stability issues.
